HOME INSPECTION REPORT

For the property located at
1401 San Miguelito Rd., Lompoc, CA 93436

Inspection Address: 1401 San Miguelito Rd., Lompoc, CA 93436
Inspection Date/Time: 2/3/2022 9:10 am to 1:10 pm

Inspected by: Martin Hewitt, ASHI Certified Inspector #202935, Master CREIA Inspector #39

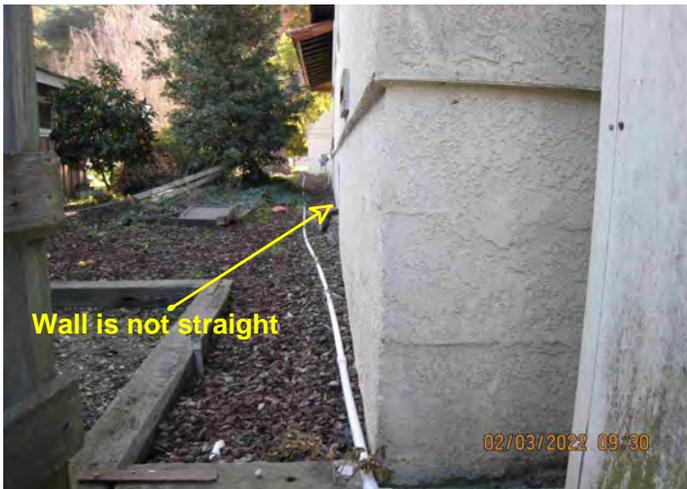
1.2 - The north concrete foundation stem wall is not straight and, although no apparent damage or structural failure was observed, you may wish to have this condition evaluated by an appropriately qualified foundation specialist, as it may be the result of an active/ongoing condition.

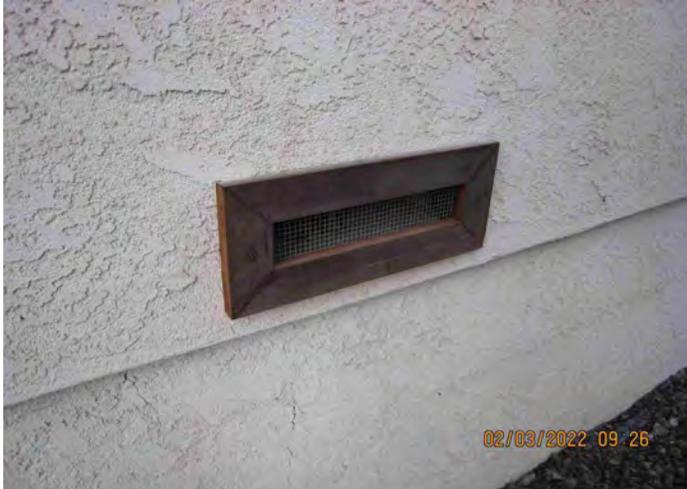
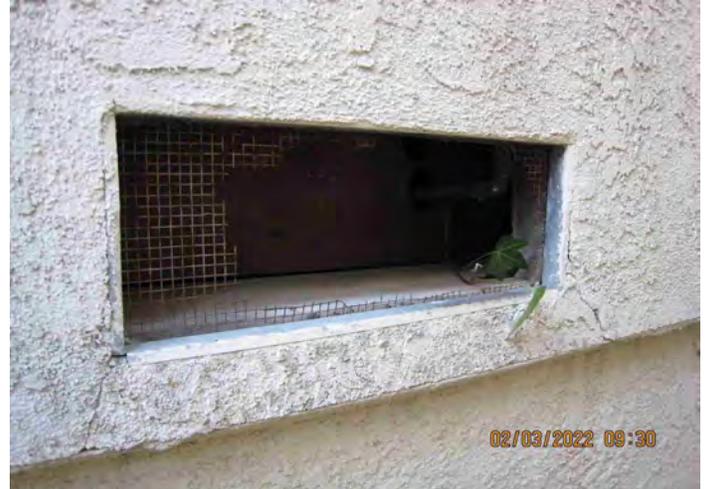
1.9 - Due to relatively recent repairs/modifications, air flow through the crawlspace vent openings has been significantly reduced. Restoring the vent openings to their original dimensions is recommended for improved air flow/ventilation. Also, a vent screen is missing at the west side of the home that will need replacing to help prevent pest entry.

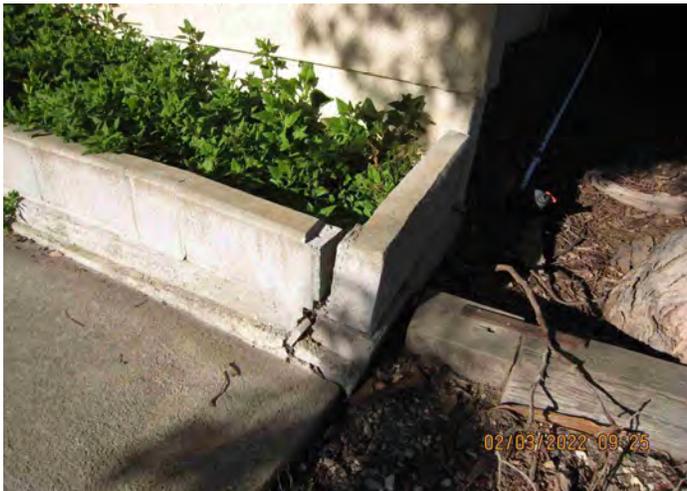
2.3 - The planter at the N/E corner of the home is cracked/damaged and needs repair. This appears to be the result of tree root uplift.

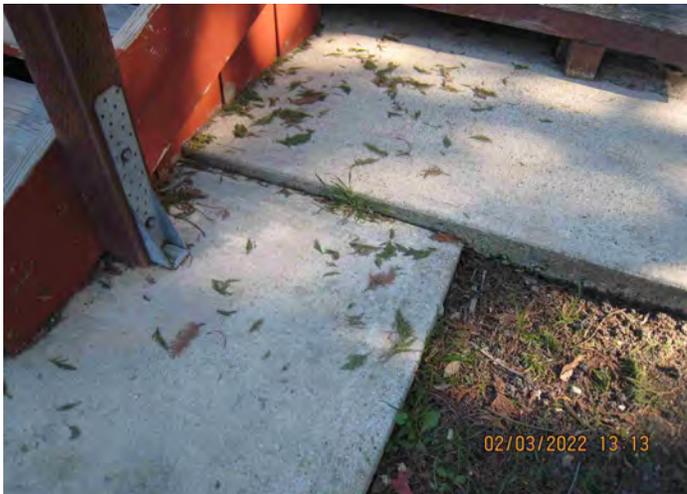
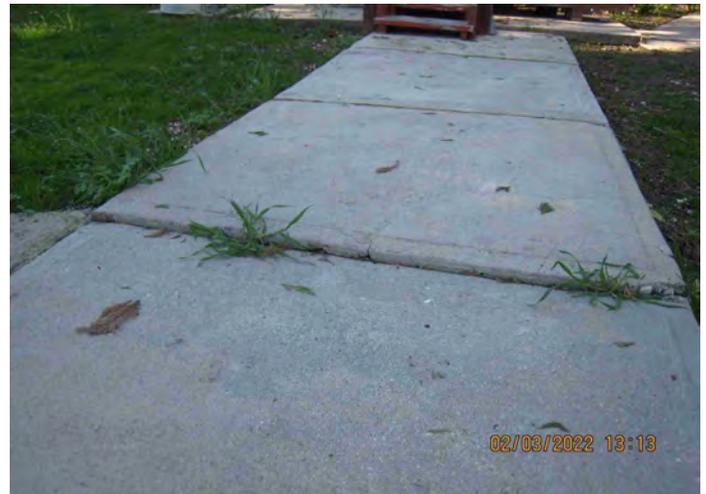
2.12 - There are offsets at the east sidewalks that could prove to be a trip-hazard if not corrected.

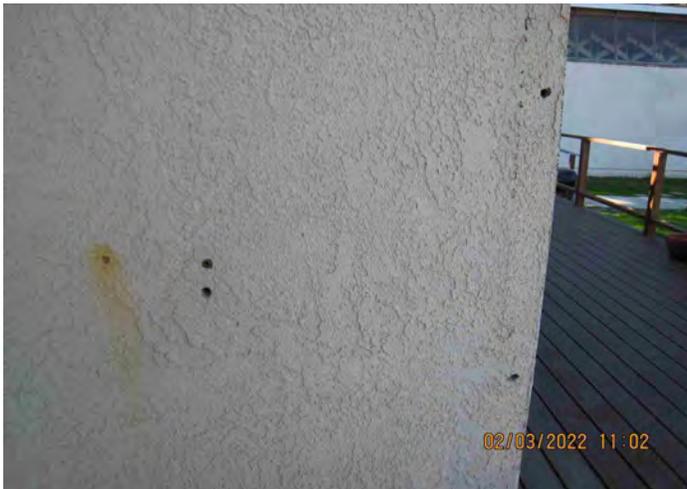
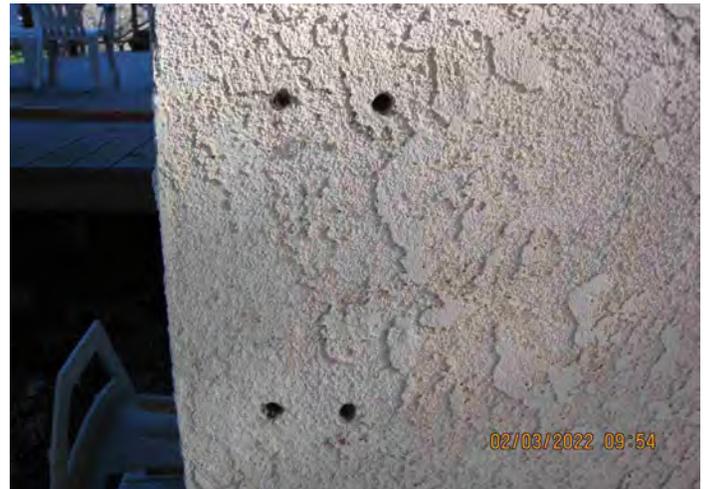
2.13 - There are small holes in the stucco siding (multiple locations) that need to be properly repaired or sealed to help prevent against moisture or pest intrusion (easily remedied).

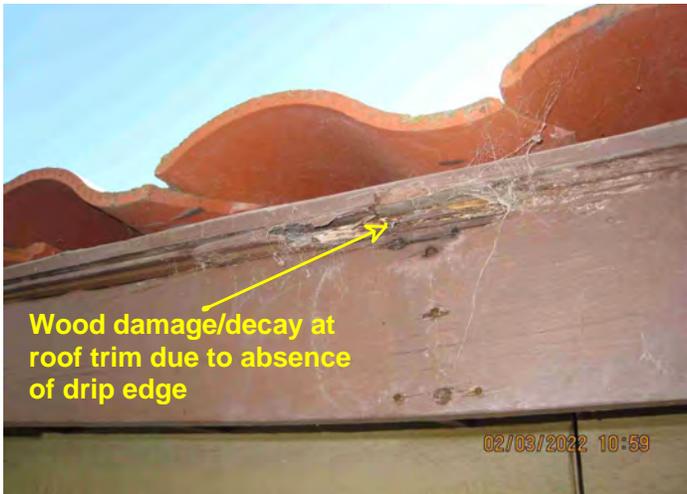
2.14 - A Branch 2 pest control (WDO) inspection and report should confirm the presence of wood damage/decay to the wood trim and fascia at multiple areas/locations and the need for any repairs/service.

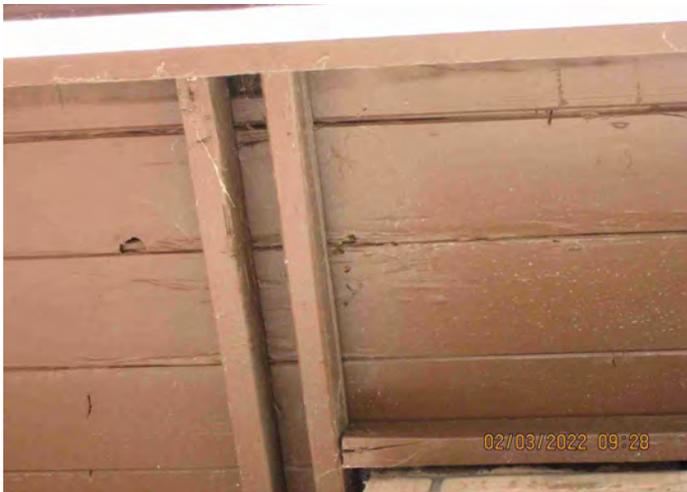
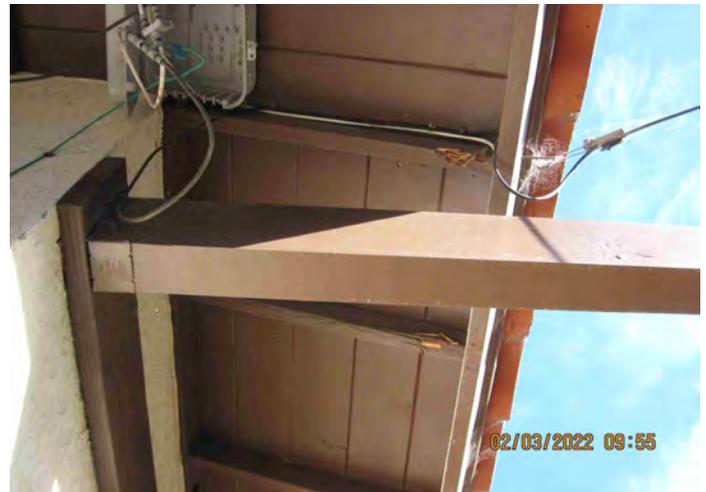
2.15 - A Branch 2 pest control (WDO) inspection and report should confirm wood damage/decay to the eaves at multiple locations and the need for repair/replacement.

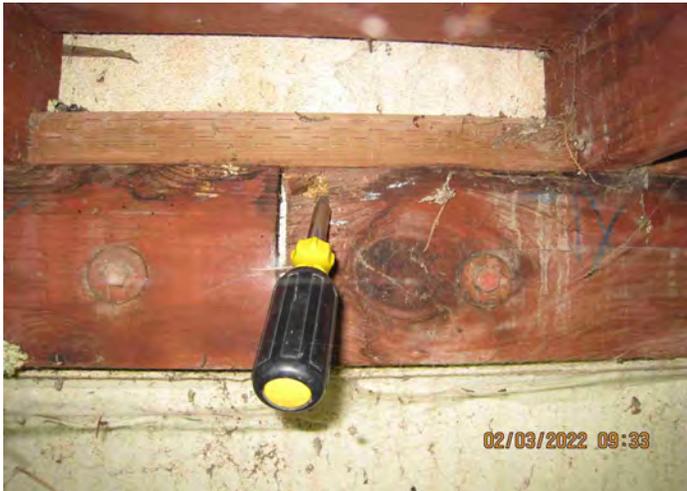
2.18 - A Branch 2 pest control (WDO) inspection and report should confirm damage/decay at the west deck and the need for any repairs/service.

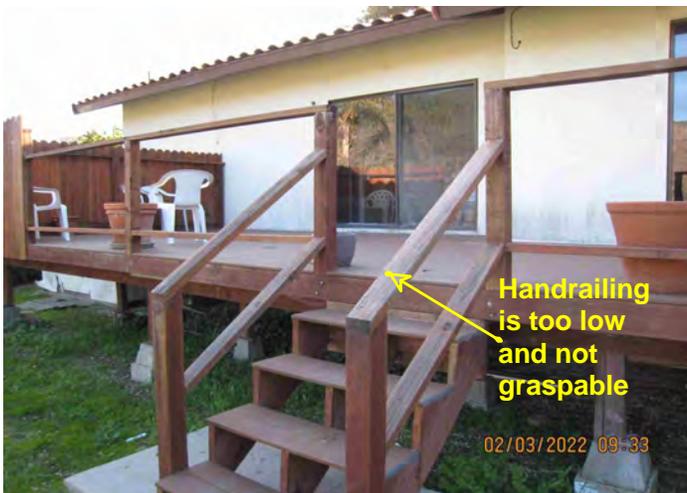
2.20 - The handrailings at the northernmost deck stairs do not conform to current safety standards, which require that they be graspable and a minimum 36 inches high, and you should have these unsafe conditions evaluated and corrected by a qualified and licensed building contractor for safety.

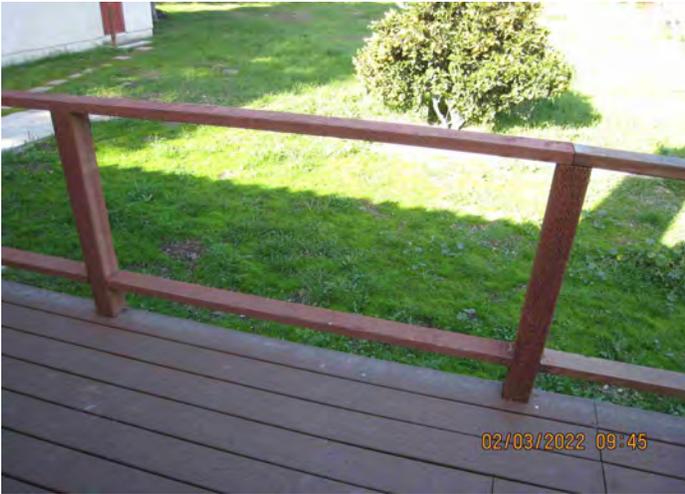
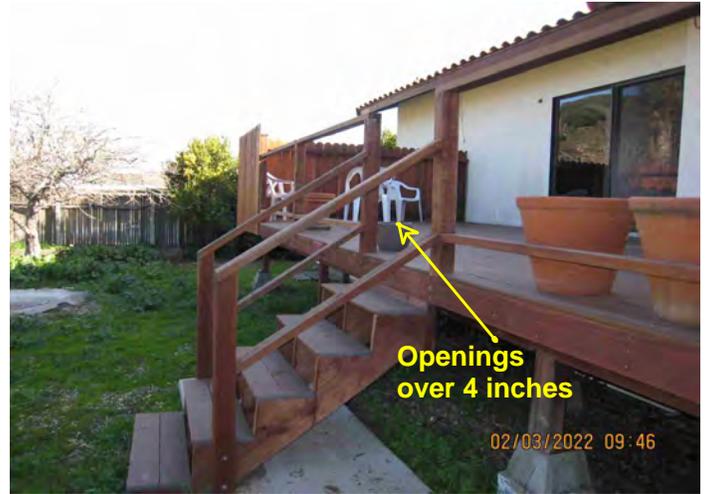
2.21 - The openings in the west deck and stair guardrailings are over 4 inches wide. Studies have proven that reducing these openings to 4 inches or less will significantly reduce the possibility of injury or death to young children and infants. We recommend a reduction in the width of these openings for safety.

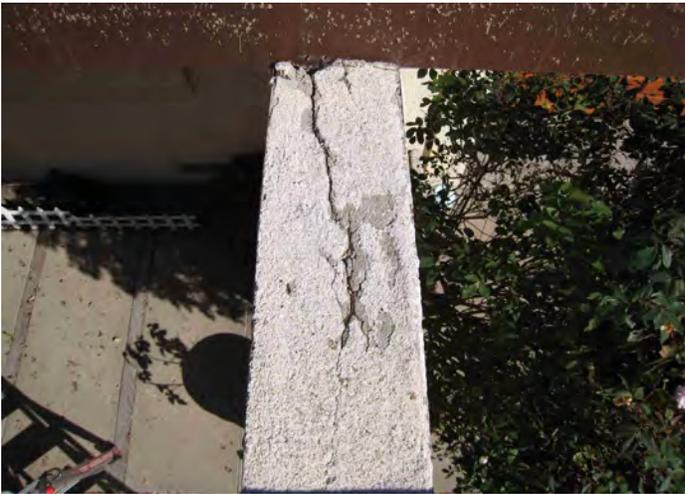
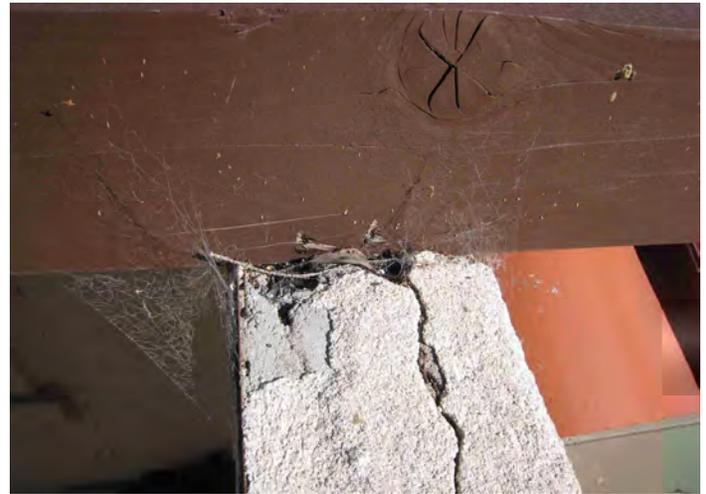
2.22 - The top surface of the stucco-covered front entry porch/patio walls is not sloped to drain and will absorb/collect moisture and must be sealed/kept watertight to help prevent water intrusion into the wall cavity and resultant damage/decay. A new coat of stucco is needed, which will also help protect the exposed wire stucco lath against rust damage/decay.

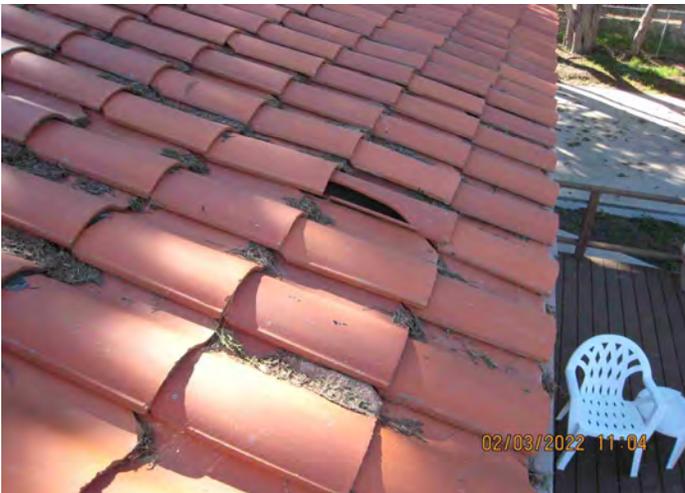
3.3 - There is a broken tile adjacent to the chimney at the west side of the home that should be replaced.

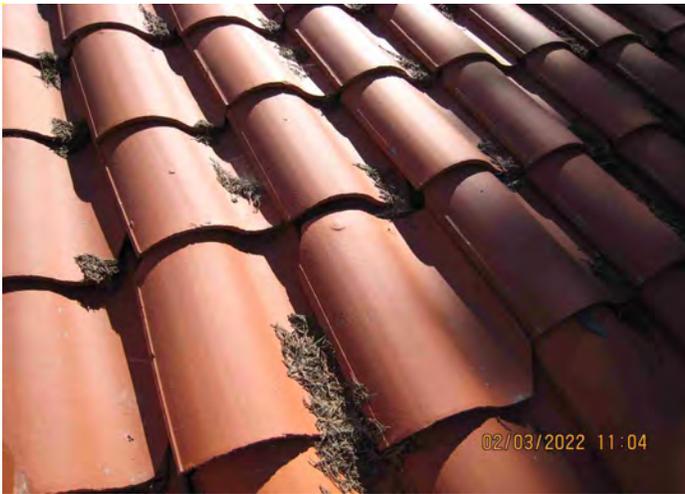
3.4 - There are a few tile at the west side of the home (around chimney area) that are not secured and have slipped out of position. Correction/repair is needed.

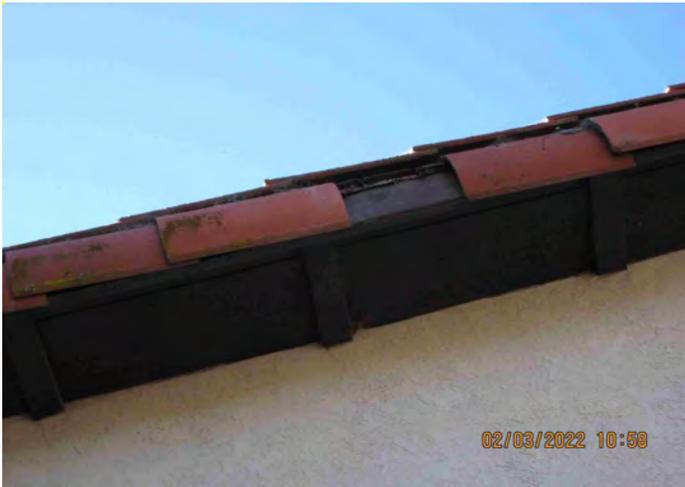
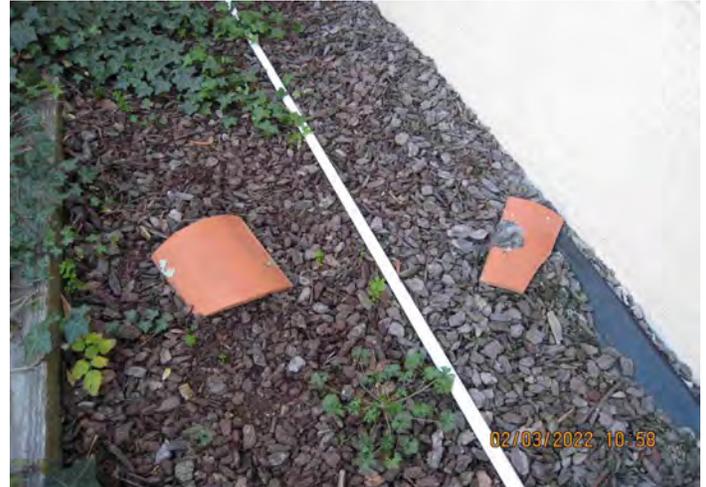
3.5 - There is a broken rake tile at the north side of the home that needs replacing.

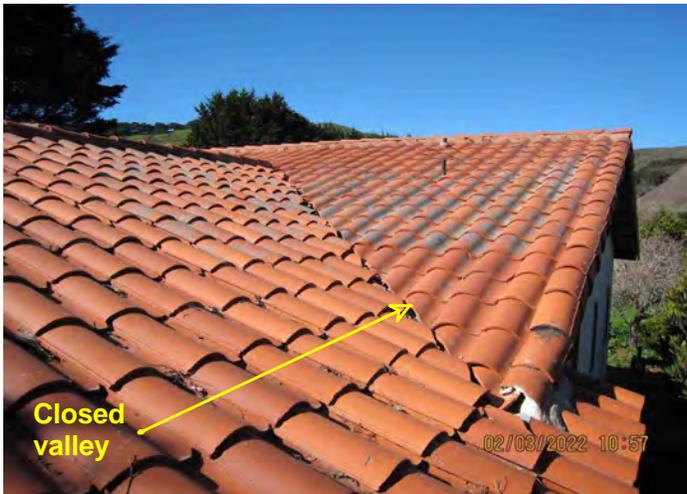
3.6 - The roof valleys are "closed", which, although more pleasing to the eye, is not desirable, as it blocks or restricts the flow of rain water and can cause damming and leakage. As a preventative measure it is advisable to have the valley tiles cut back (or "opened") to improve drainage and help prevent leakage.

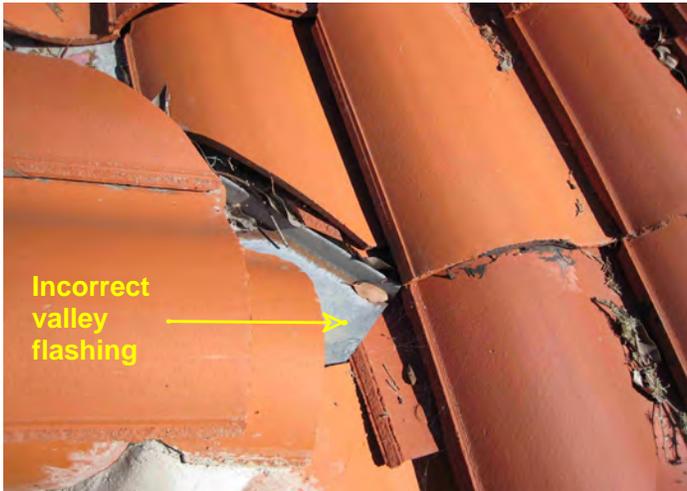
3.10 - The valley flashing is incorrectly installed at the east side of the home. This condition, if not corrected, may result in roof leakage and resultant water damage.

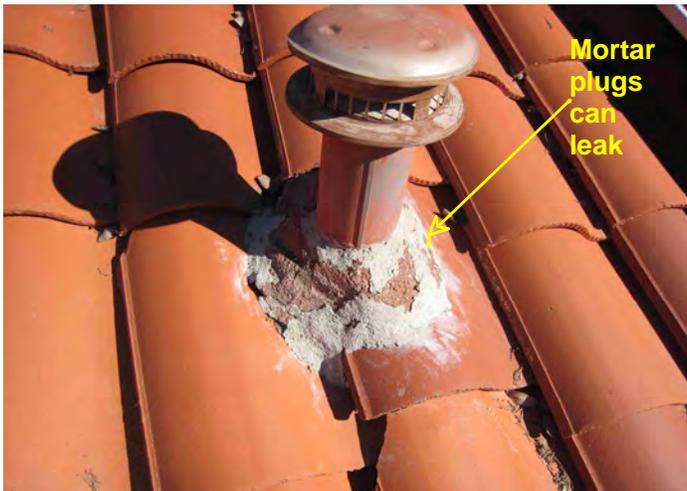
3.11 - Mortar plugs are being used instead of flashings at some of the roof penetrations, which is not unusual given the age of the home and building practices that existed at the time the home was constructed. However, mortar plugs will eventually crack and deteriorate, and for this reason need to be monitored and maintained regularly or they will leak. We recommend that you have them replaced with malleable metal flashings as is now found in newer construction to preclude the possibility of leakage (preventative upgrade).

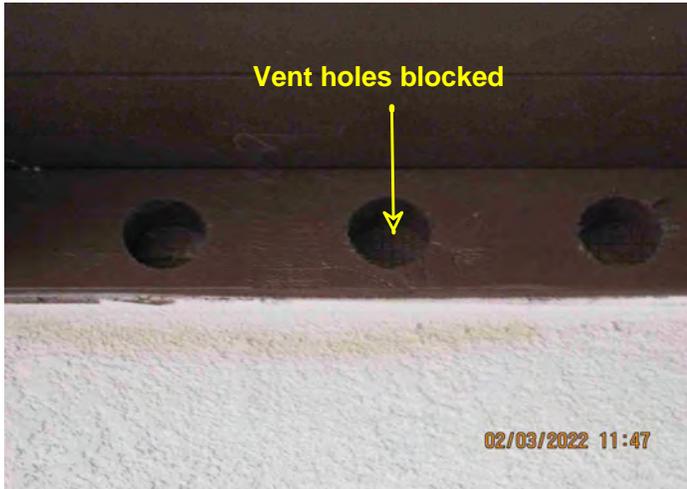
4.2 - Some of the ventilation ports have been partially sealed or covered with wood, which should be removed because it limits attic air flow and defeats the purpose of the vents.

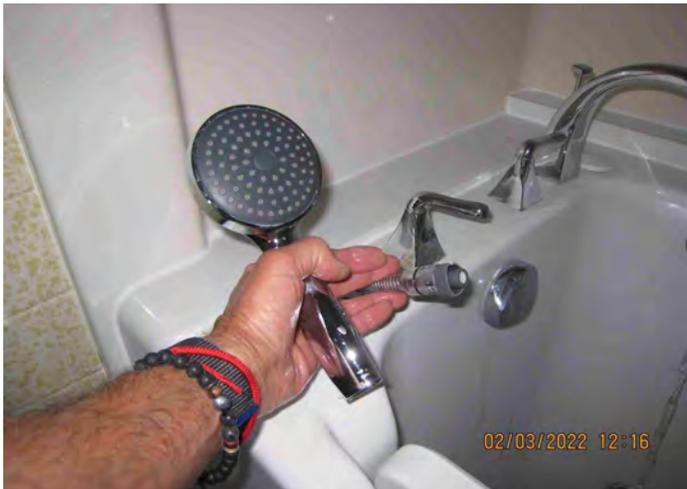
5.11 - The spray wand at the master bathroom Jacuzzi tub is damaged and needs service.

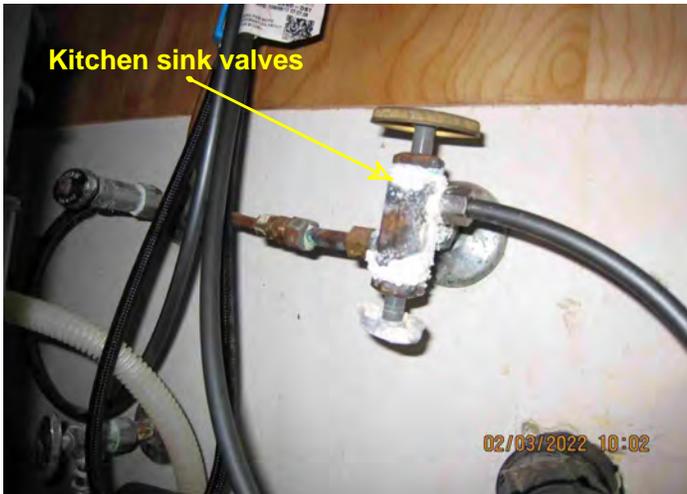
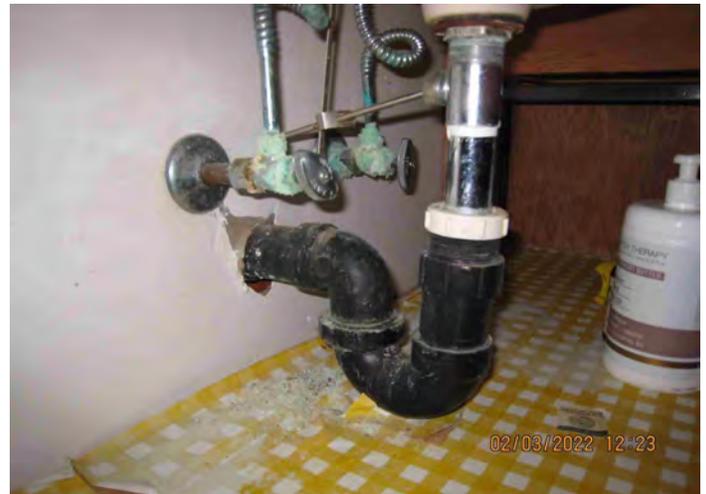
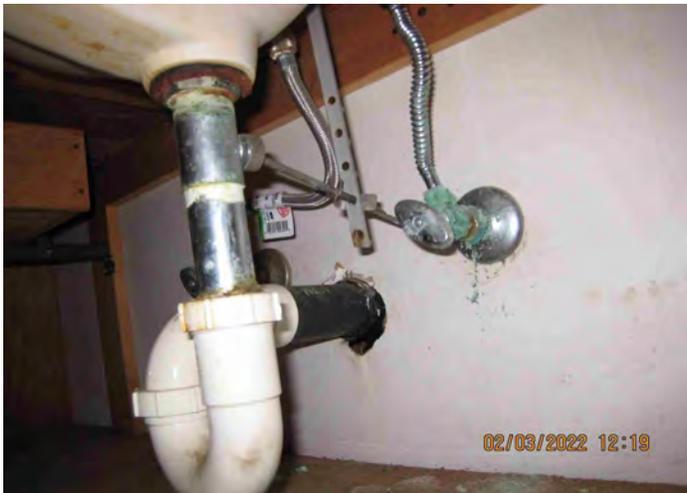
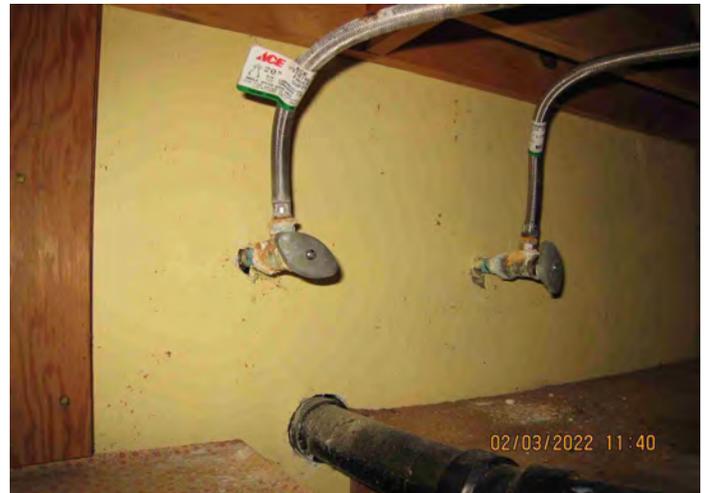
5.12 - The bathroom, laundry, and kitchen sink valve handles and their connectors/connections are all older/original and show significant corrosion and leakage and should be replaced at this time.

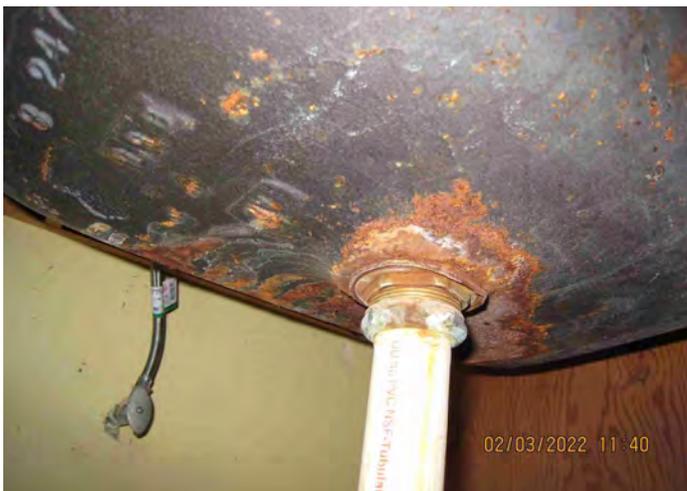
5.13 - The underside of the metal laundry sink is excessively rusted and the sink will need to be replaced.
Note: The sink appears to be actively leaking at this time.

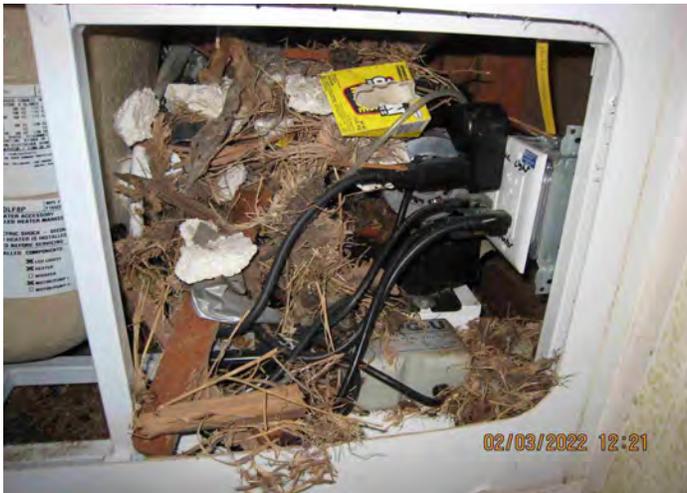
5.18 - There is evidence of animal activity and possible nesting beneath the master bathroom Jacuzzi tub that prevented an evaluation of the tub plumbing and electrical components. Unseen damage/defects may exist. We recommend that the area be cleaned/cleared of all debris and the equipment evaluated and tested for safe and proper function prior to the close of your inspection contingency period. The tub was not filled with water or tested by your inspector.

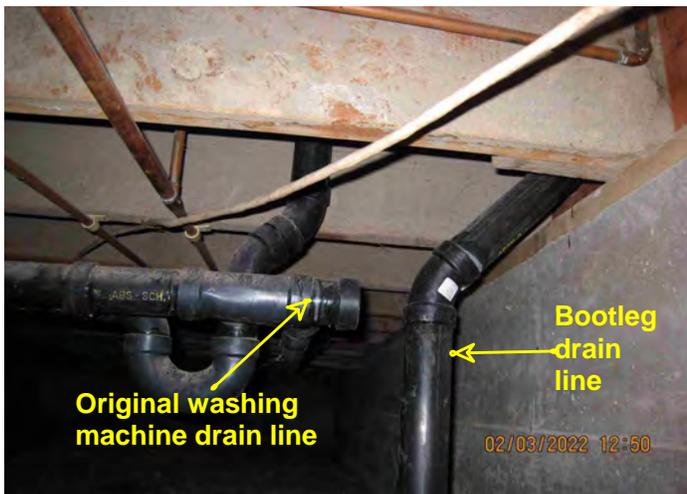
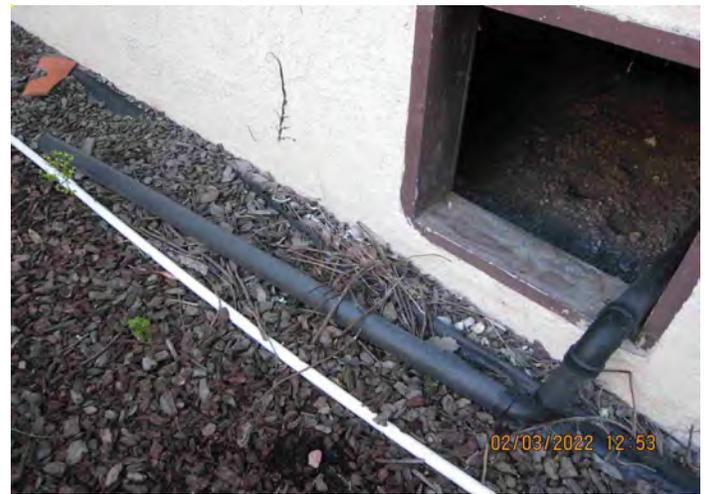
directly adjacent to the home and its foundation. This condition, which is not permitted, can also result in foundation/structural damage and should be corrected.

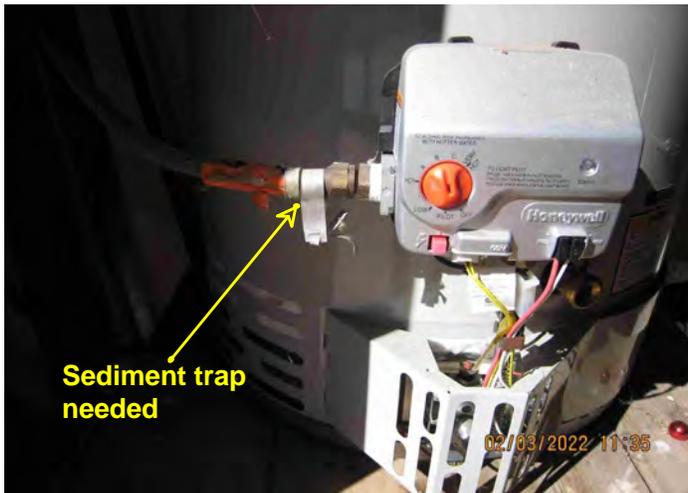
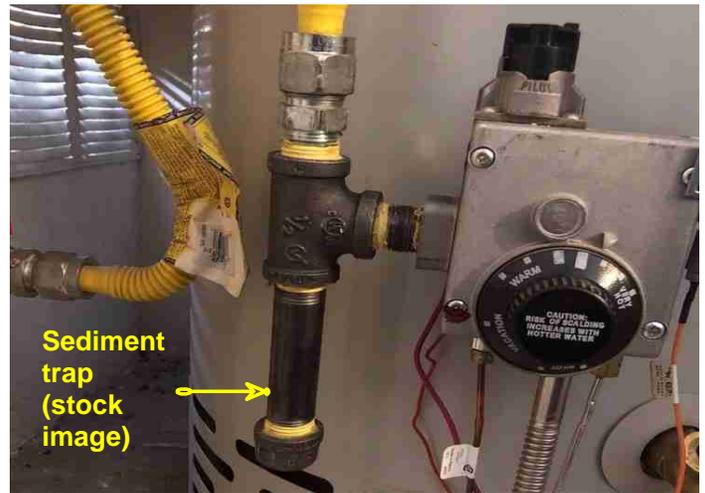
5.33 - A sediment trap is needed on the water heater gas line as is normally required. This is easily remedied and will help collect sediment, rust, debris, etc. in the gas piping system that can clog the burners and cause a malfunction.

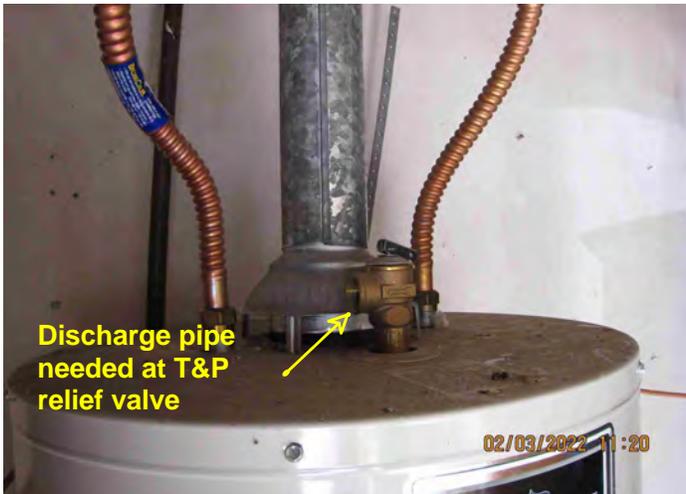
5.38 - There is no discharge pipe on the water heater T&P relief valve, which represents a potential scalding hazard and which can result in water damage should the valve ever leak. One will need to be installed and made to terminate at a visible location at the exterior of the home and within six inches of the ground.

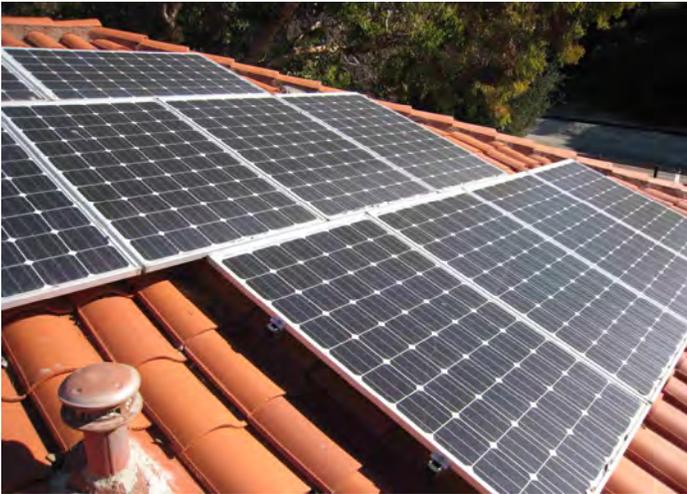
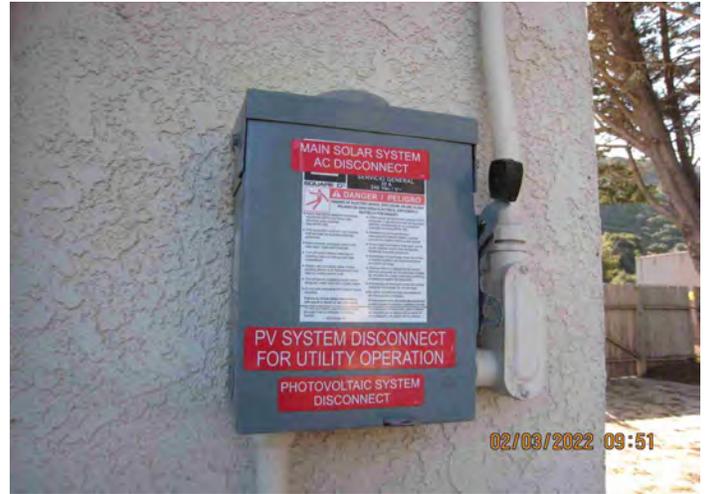
6.2 - Solar electric system components have been added and modifications to the original service panel were noted. Due to their complexity, inspection of solar electric systems and their components and any/all modifications or additions to the original electrical equipment falls outside the scope of a home inspection and our services. If this is a concern, we recommend that you have the system evaluated by an appropriate specialist at this time.

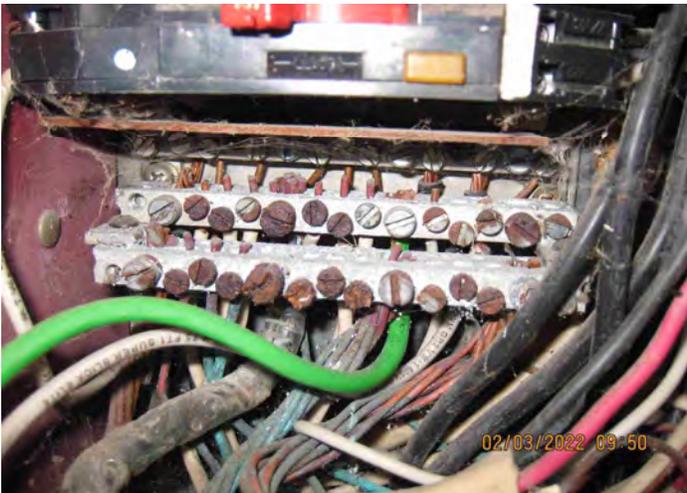
6.4 - It appears that water has entered the main panel, which has rusted/corroded some of the panel components (bus bars, etc.). Oxidization of the bus bars was also observed. Further evaluation and correction is advised for safety/other.

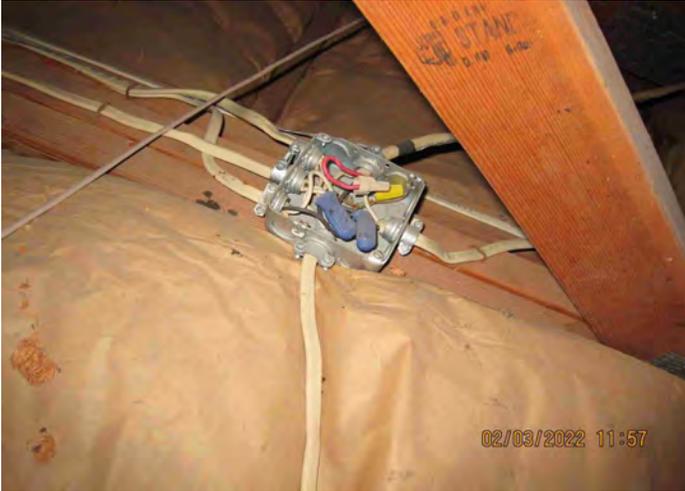
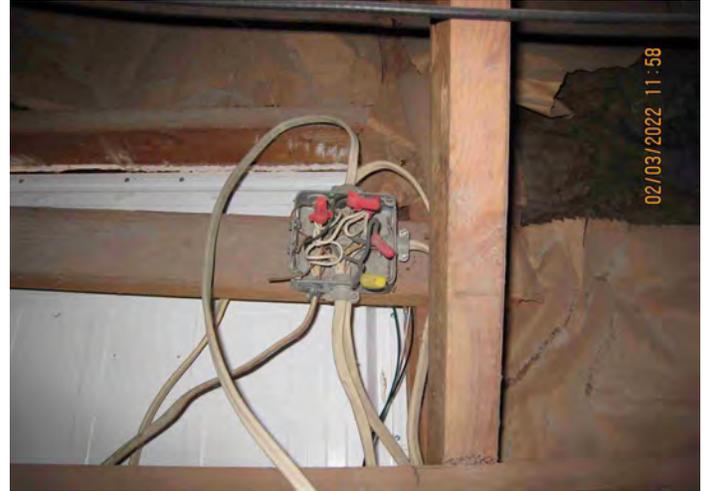
6.16 - There are approximately 8-10 open electrical junction boxes within the attic. The boxes should be sealed so that any arcing or sparking would be contained within the boxes.

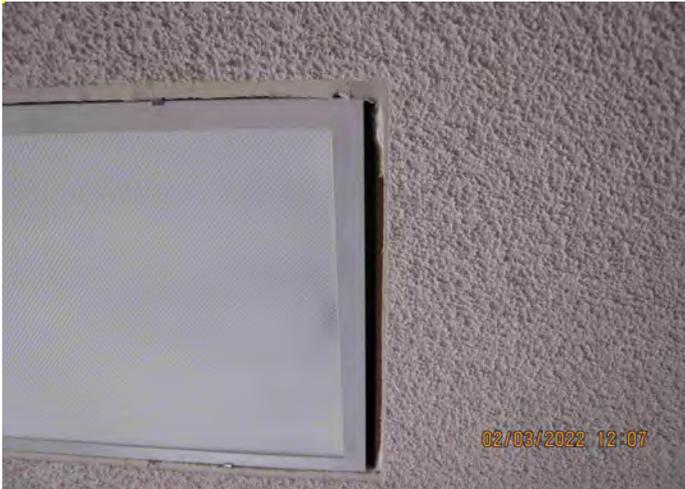
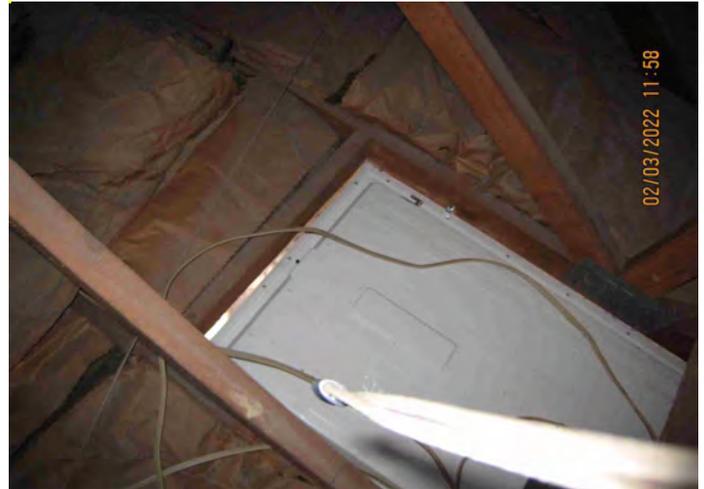
6.29 - The trim is missing or was never installed around the two dining room light fixtures. This has left large gaps/openings around the fixtures that are open to the attic. Among other things, this is an unsanitary condition. Correction is recommended.

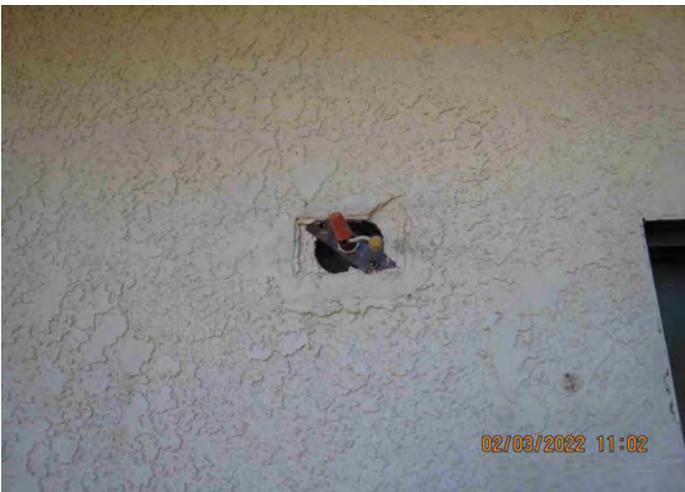
6.30 - There is a missing light fixture at the west exterior that will need to be replaced.

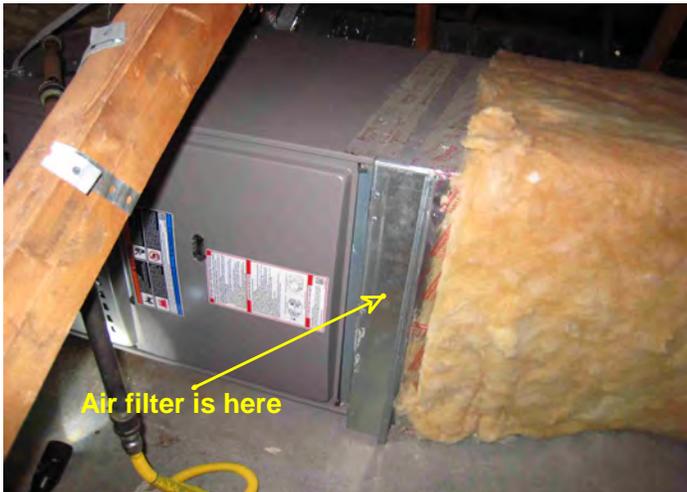
7.6 - The filter (at furnace) is dirty and should be changed right away and then again every two or three months thereafter. A clean air filter significantly reduces particles in the breathable air and will help keep the home clean. It will also help protect the mechanical equipment and help prevent mold and bacteria from growing within the system. Most importantly, it will help prevent dirt from clogging the interior of the furnace that can cause the heat exchanger to overheat and crack. A cracked heat exchanger can circulate deadly carbon monoxide throughout the home.

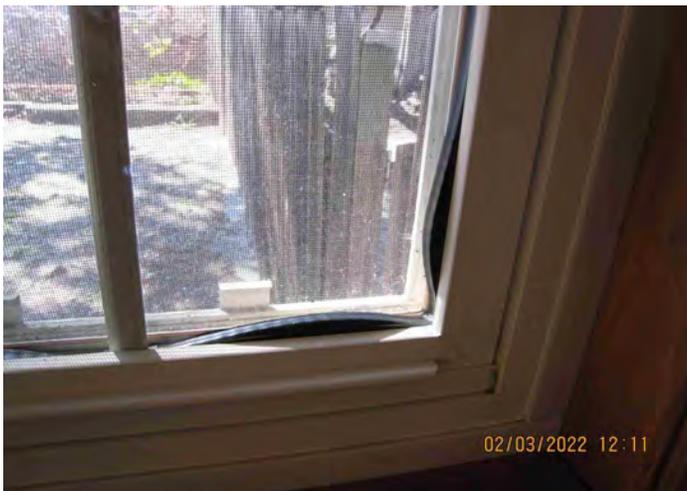
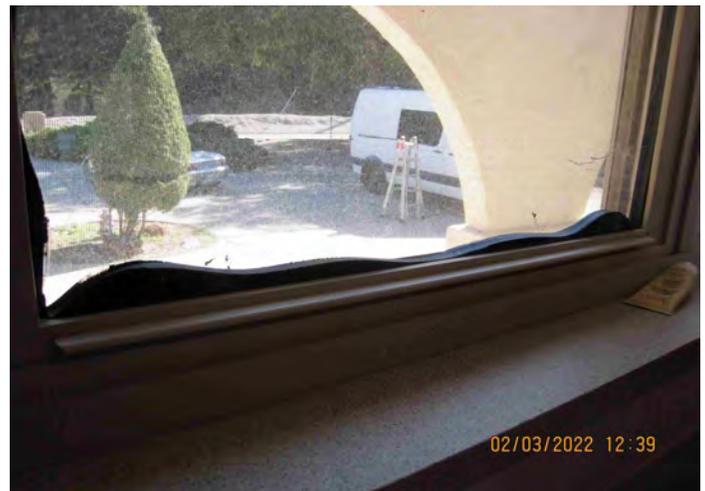
8.2 - Window trim has become distorted inside many of the windows. This condition is normally considered to be a cosmetic one but we recommend that you have the manufacturer confirm this.

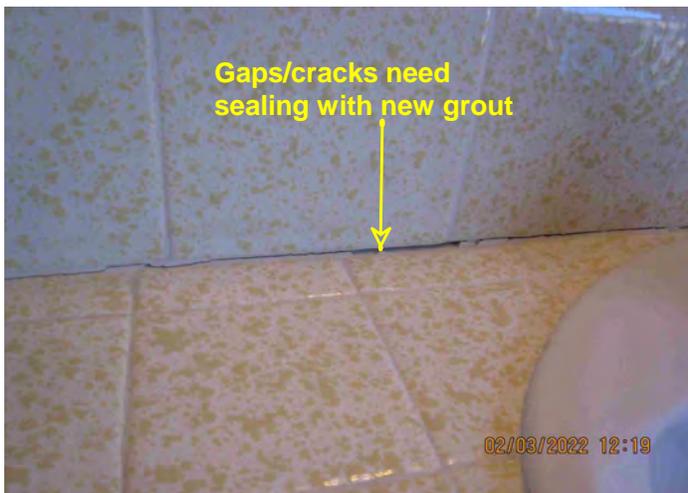
8.10 - There is a typical separation between the kitchen and bathroom sink countertops and back-splashes that should be repaired/sealed to help prevent water from getting through. It appears that water has already entered into some of the cabinets.

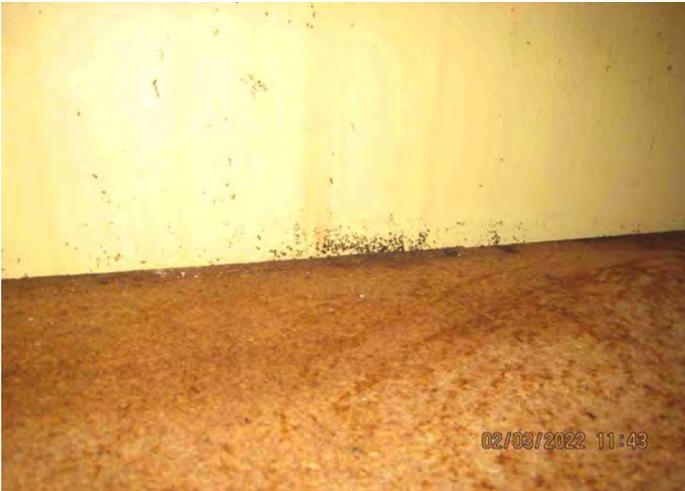
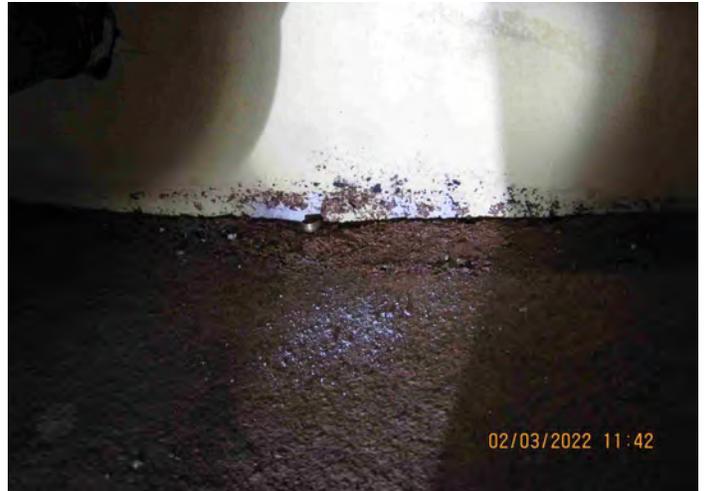
8.11 - There is a black staining inside the south bathroom (off laundry room) sink cabinet that we recommend you have evaluated for mold by an appropriate specialist. Mold flourishes in damp, unventilated areas and many are commonplace, but some molds are toxic and present a serious health threat to some people. This condition appears to be the result of a water or drain line that leaked at some point in the past.

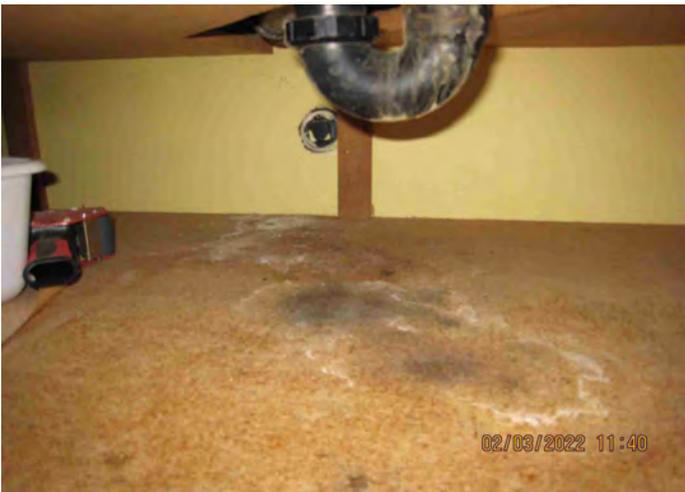
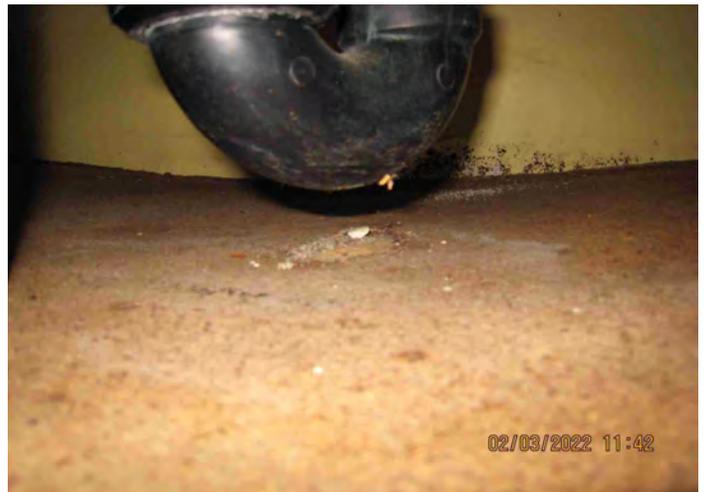
8.12 - There are water or corrosion stains beneath the bathroom, kitchen, and laundry room sinks that could not be readily explained (no active leakage) and that should be evaluated by a licensed plumber for further remarks and recommendations.

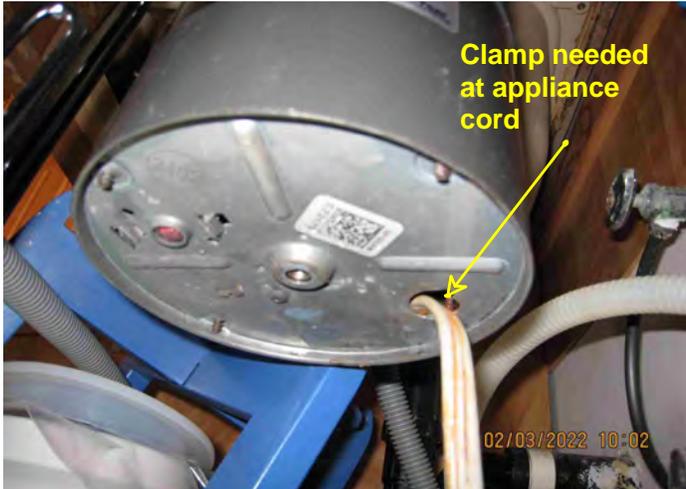
8.15 - The electrical connection to the food waste disposal should be clamped to the unit to prevent the cord from pulling loose (safety hazard).

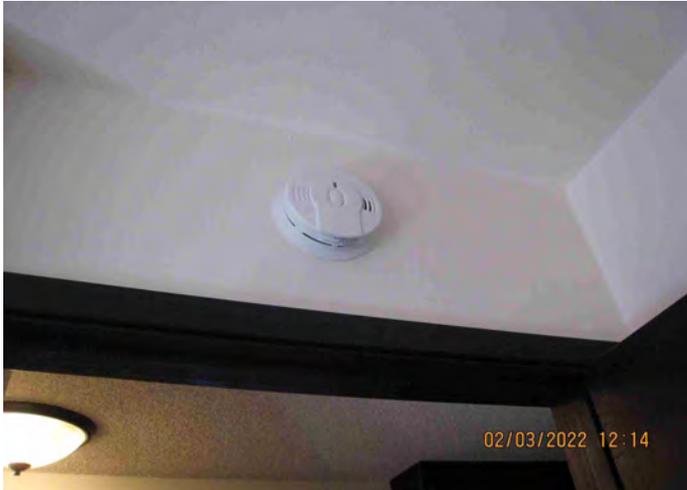
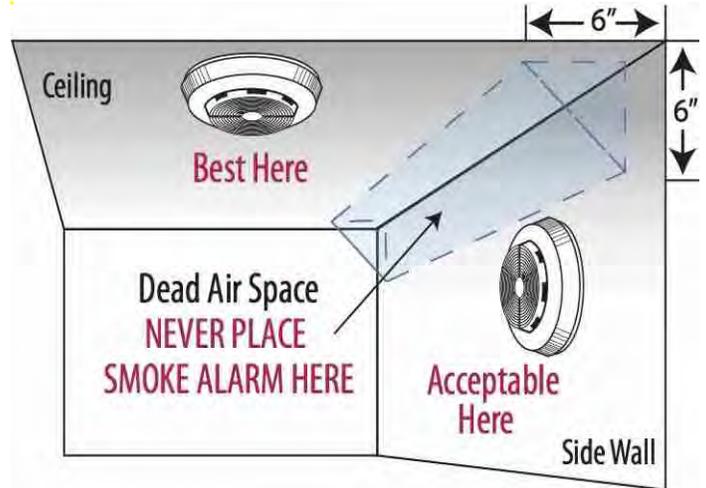
8.33 - The smoke alarms in the bedrooms are not in a location normally recommended by smoke alarm manufacturers. Typically, smoke alarms are required to be within 12 inches of the highest part of the ceiling but no closer than 6 inches, and preferably not located directly above a door opening.

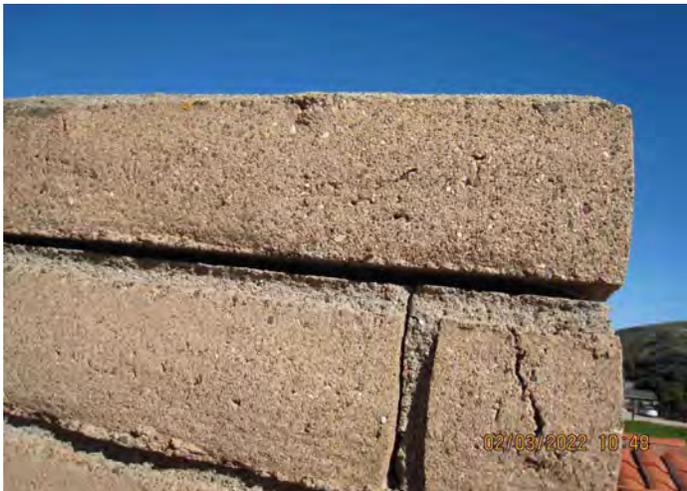
9.9 - The chimney crown, which is designed to seal the chimney wall and shed rainwater, has some cracks/openings that should be sealed/repared to help prevent moisture intrusion. Also, the top layer of brick beneath the crown has lifted, and will need to be evaluated and repaired as deemed necessary by a qualified and licensed chimney specialist.

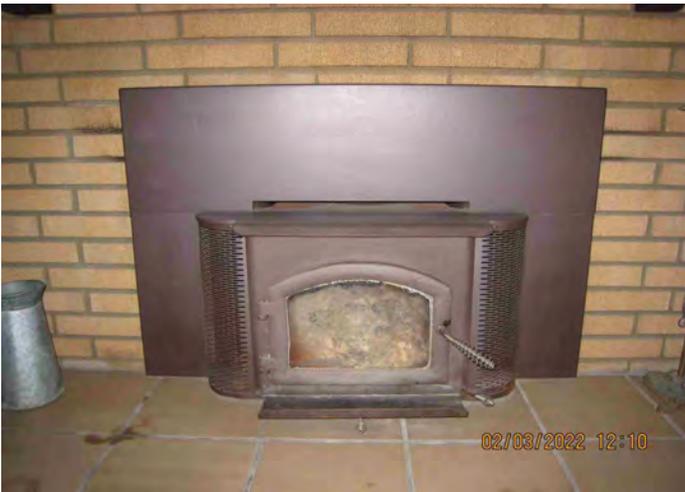
9.12 - The masonry fireplace and chimney system has been fitted with a metal fireplace insert. A visual inspection of the interior hearth and chimney components could not be performed. In addition, evaluation of manufactured metal fireplace inserts is not included as a part of our inspection, as we are not familiar with the manufacturer's installation instructions, listings, specifications, local code applications and adoptions of this type of equipment. It is therefore recommended that an appropriately qualified fireplace specialist familiar with this type of heating equipment be retained to perform a full evaluation, which will necessitate removal of the insert to confirm its proper installation, an evaluation of the venting system, and the current condition of the interior hearth components.
