HOME INSPECTION REPORT

For the property located at
1401 San Miguelito Rd., Lompoc, CA 93436

Inspection Address: 1401 San Miguelito Rd., Lompoc, CA 93436
Inspection Date/Time: 2/3/2022 9:10 am to 1:10 pm

Inspected by: Martin Hewitt, ASHI Certified Inspector #202935, Master CREIA Inspector #39

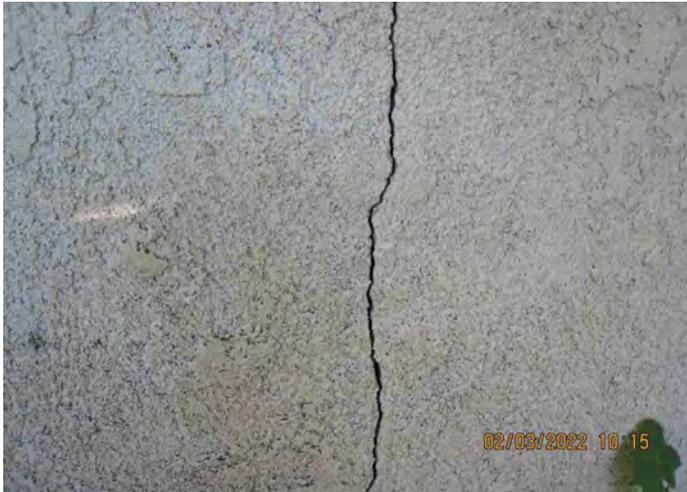
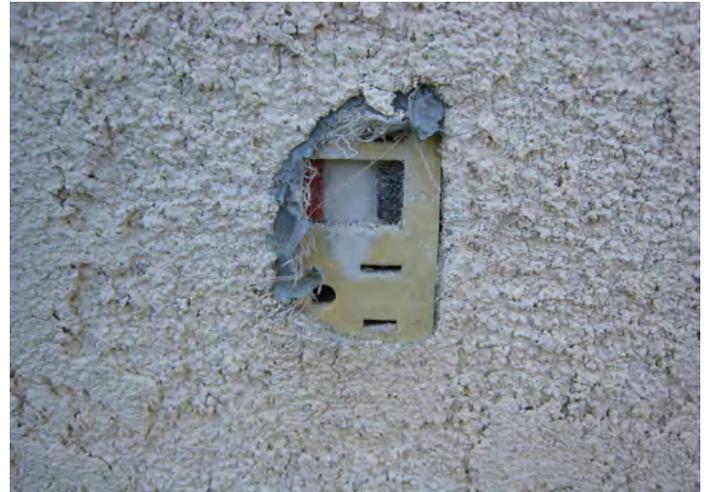
10.9 - There are stucco cracks or stress fractures at the south side of the workshop that we recommend be evaluated further and then repaired by an appropriate specialist. Also, there is a receptacle outlet at the north side of the home that has been covered over with stucco. This stucco installation appears substandard/amateurish and we recommend that it be evaluated by an appropriate specialist at this time for further comment.

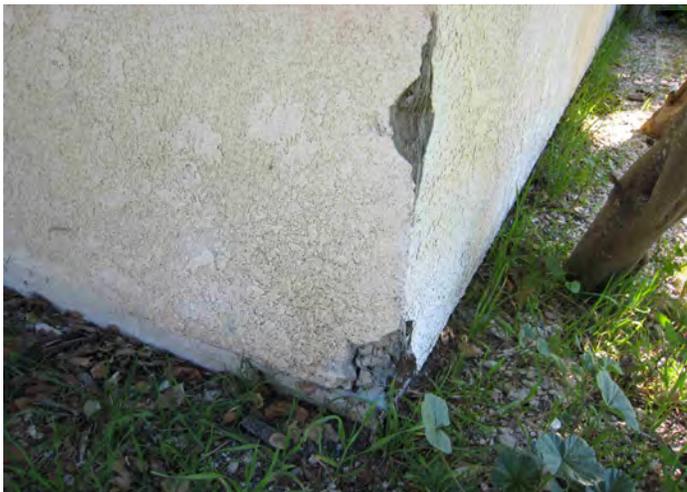
10.10 - Damage to the stucco wall covering was observed at the S/W corner of the building that we recommend be repaired.

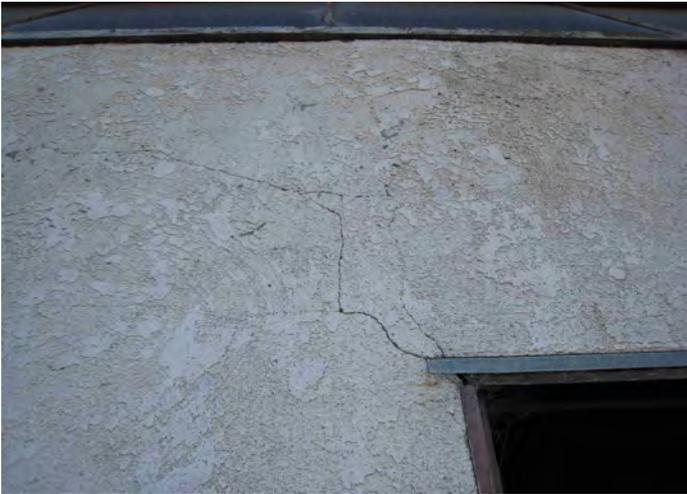
10.11 - There are cracks in the stucco wall covering at the north side of the building. Stucco cracks are not uncommon and are often the result of structural movement or poor installation, or a combination of same, but determining the exact cause of any given crack can be difficult. In any event, the cracks appear to be wide and/or deep enough to warrant sealing or repairing them to help guard against moisture intrusion.

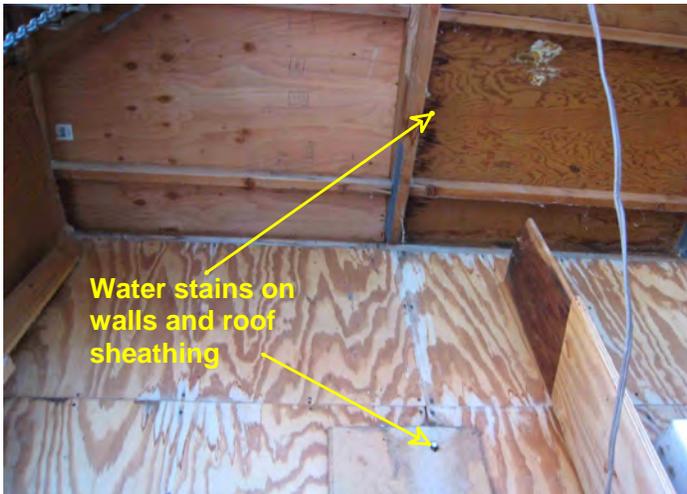
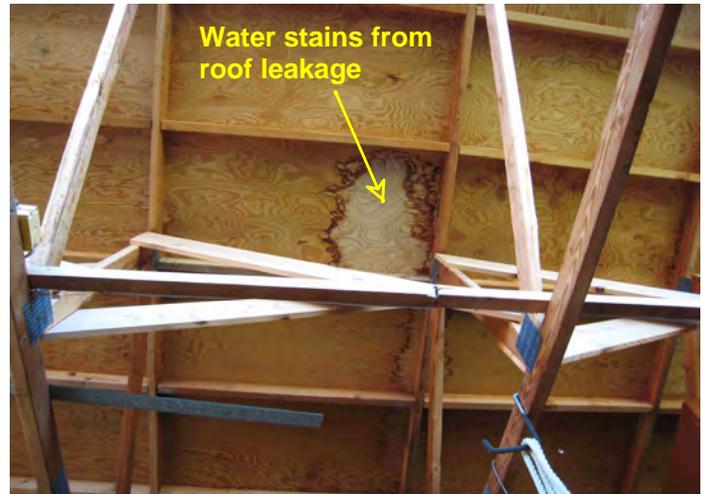
10.14 - There are water/moisture stains on the walls and roof sheathing inside the workshop that indicate prior roof leakage, but at this time there is no visible/apparent damage to the tile roof itself. The roof may have been repaired to address the leakage, but we have no knowledge of this, and therefore recommend that you ask the seller(s) if there have been any recent repairs made to the roof. In any event, because there are no guarantees that the roof is not still leaking, we recommend that you have the roof covering evaluated by an appropriately qualified and licensed roof contractor at this time for further remarks and recommendations.

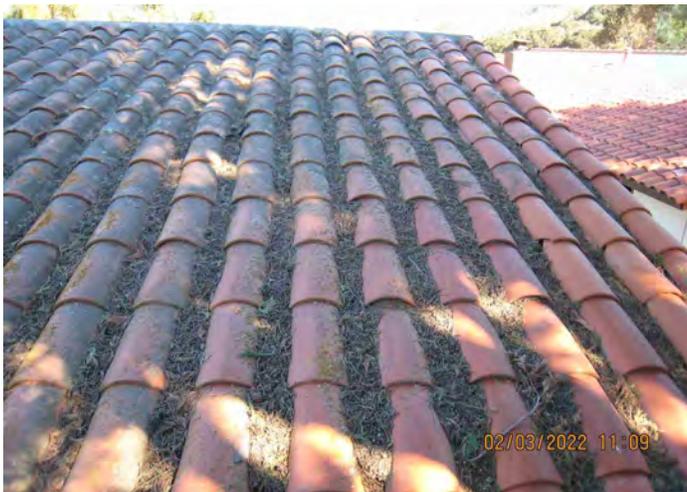
10.15 - The tile roof needs to be cleaned to drain effectively.

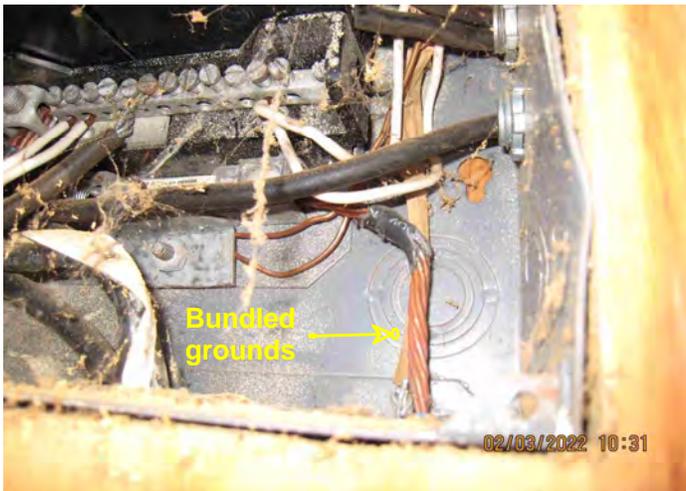
10.25 - The circuit ground wires are intertwined and sharing the same lugs at the buss bar, which is incorrect and a safety concern. Although this condition is quite common, it is easily corrected by individually connecting (or even doubling up) each ground wire to the grounding buss.

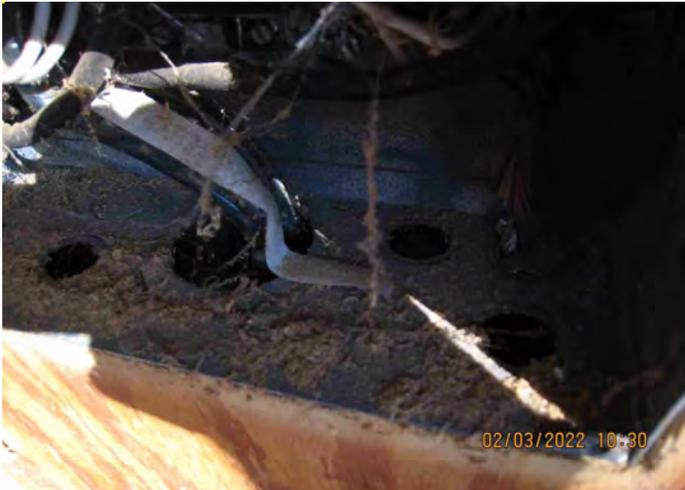
10.28 - For fire safety reasons, the uncovered holes or knock-outs inside the panel should be plugged. Also, the wires that pass through the knockouts need bushings/clamping.

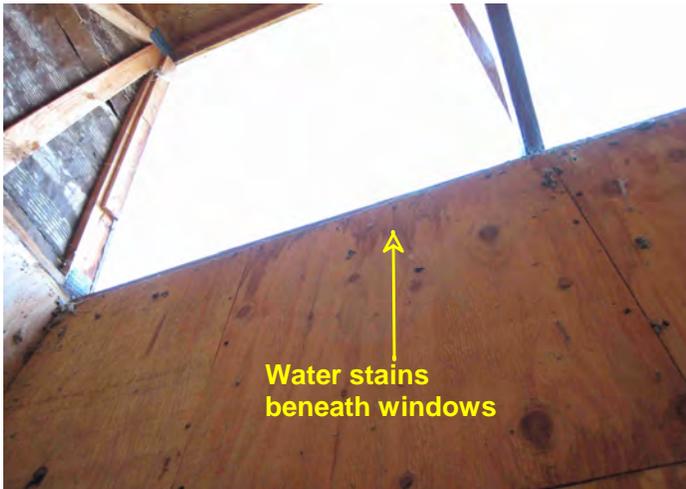
10.29 - There is evidence of leakage (water stains) at many if not all of the north windows. Repair/replacement is needed.
