HOME INSPECTION REPORT

For the property located at
1401 San Miguelito Rd., Lompoc, CA 93436

Inspection Address: 1401 San Miguelito Rd., Lompoc, CA 93436
Inspection Date/Time: 2/3/2022 9:10 am to 1:10 pm

Inspected by: Martin Hewitt, ASHI Certified Inspector #202935, Master CREIA Inspector #39

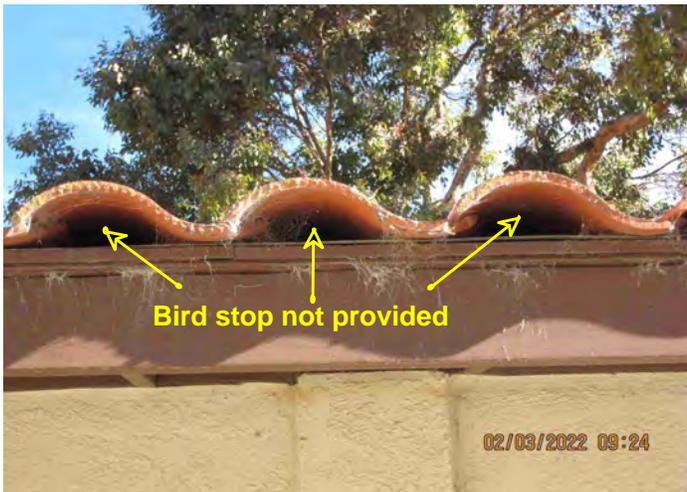
3.7 - Bird stop flashing was not installed beneath the first course of tile at the eaves. Installing this flashing prevents birds and rodents from getting beneath the tile.

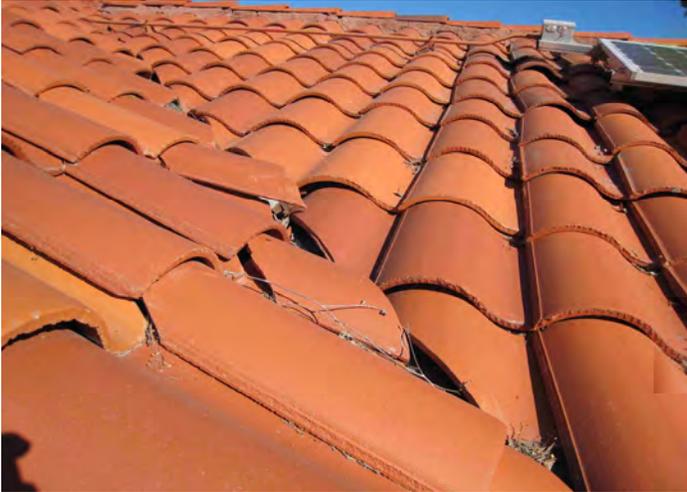
3.12 - The closed valley flashings are blocked in some areas and should be serviced to ensure proper drainage.
